Waves, Surge and Damage on the Bolivar Peninsula During Hurricane Ike

Andrew Kennedy, Matild Dosa, Francisco Zarama, and Jonathan Rager
Department of Civil Engineering and Geological Sciences
University of Notre Dame
Notre Dame, Indiana 46556 USA
Email: Andrew.kennedy@nd.edu
Phone: +1 574-631-6686

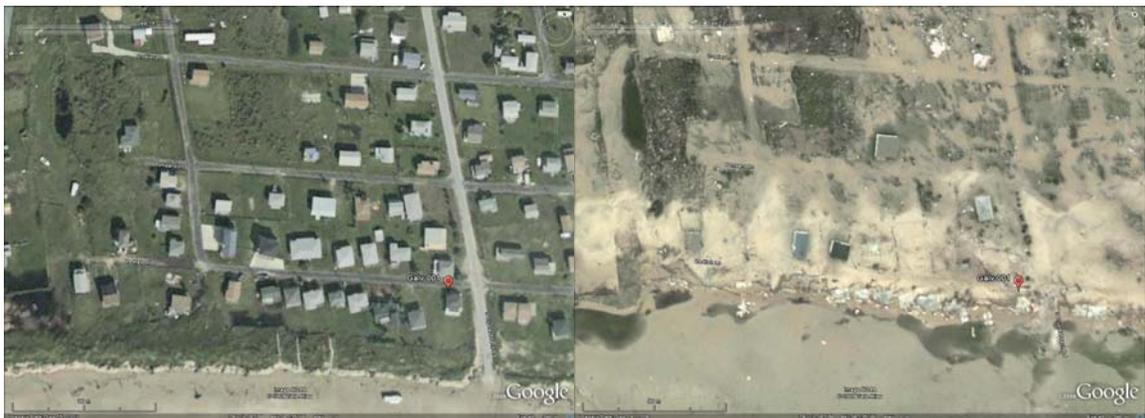
Figure 2 gives an example of the destruction, with pre-and-post-storm satellite photos of the same area near the USGS gauge GAL-1 by the Gulf of Mexico. Shoreline erosion was around 75 m, which undermined the piled foundations of oceanfront buildings. Most other houses in this area were reduced to either piles or slabs by large waves riding on surge, with only a few remaining more or less intact.

Figure 2. Google Earth images of the same location at GAL-1 taken before the storm (left); and after (right).

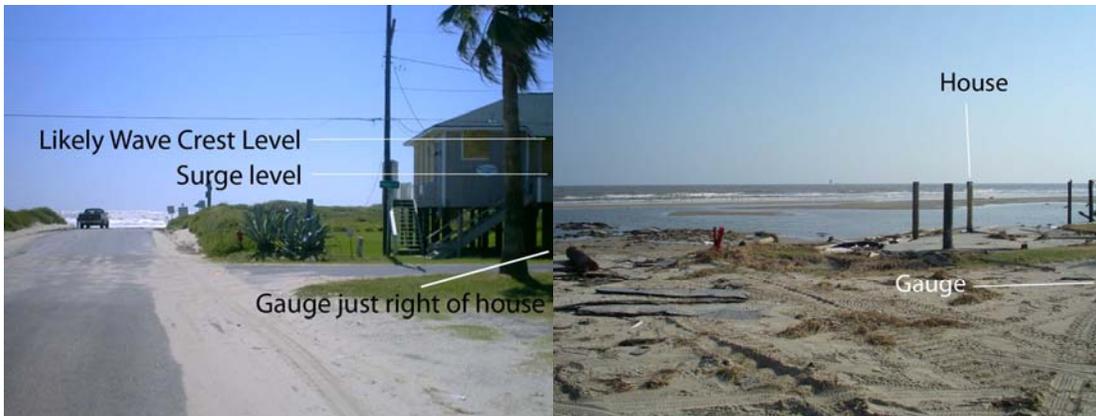
Damage levels at GAL-1 and GAL-2 were correspondingly different as well. Figure 5 shows ground level photos taken from the same location before and after the storm immediately next to GAL-1. Estimates of the inundation level superimposed on the photograph show wave crests reaching nearly to the roof. With measured significant overland wave heights of 1.8m at this very location, it is not a surprise to see that the elevated house was completely destroyed. This destruction was made easier by the complete removal of the dune during the storm.

Figure 5. The same location at Crystal Beach, Texas before and after Hurricane Ike. The USGS surge gauge GAL-1 was located just to the right of this house. Note the complete removal of the protective dune fronting the island. Photos courtesy USGS.

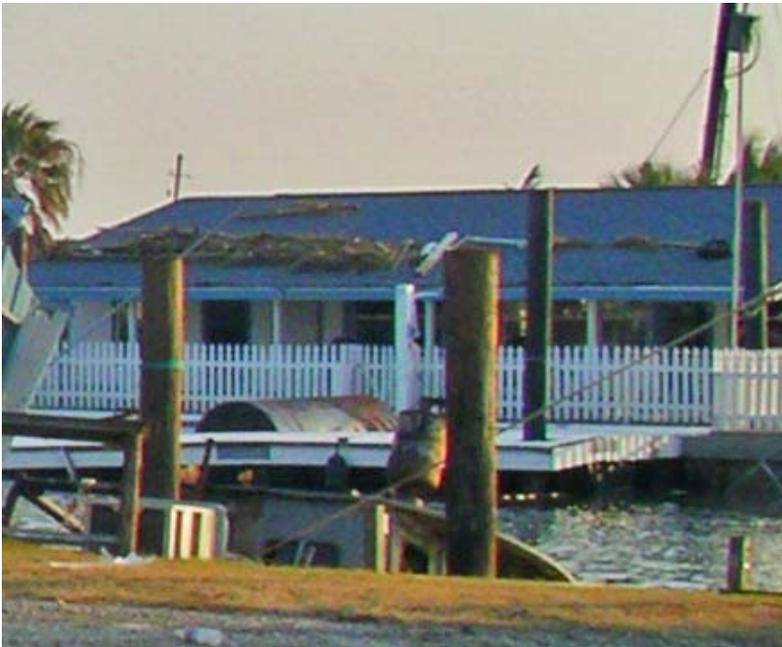
A much different picture is found in Figure 6 taken nearby GAL-2. Here, an at-grade house was inundated to partway up its roof, and survived with no apparent structural damage (although certainly major interior damage), and little damage to even its flimsy picket fence. The major difference between GAL-1 and GAL-2 here was the wave height: waves at GAL-1 were large, and waves at GAL-2 were tiny after presumably dissipating overland. This difference in wave height (and consequently breaking waves changing to non-breaking waves) led to corresponding differences in damage, leading to large differences in building survival.

Figure 6. Surviving at-grade house less than 100m from gauge GAL-2 on the GIWW. Note debris lines on roof showing the extent of inundation, and the survival of a presumably flimsy picket fence. Maximum wave heights here were approximately 0.2-0.5m.

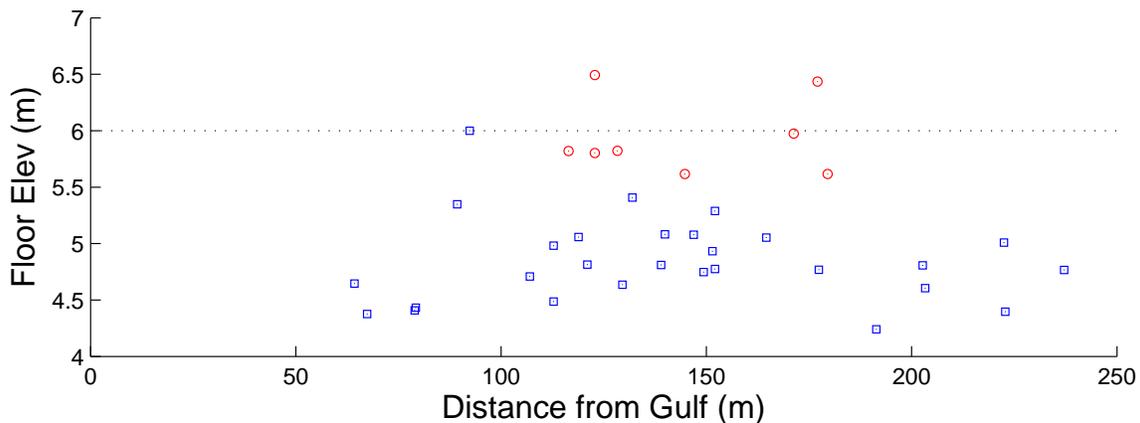
Building elevation proved to be a very good delimiter between survival and destruction. The floor elevation from grade could be measured directly on surviving houses, and could be estimated reasonably accurately on many houses that were largely destroyed. Figure 7 shows survival and destruction near gauge GAL-1 compared to elevation and distance from the nominal pre-storm shoreline. The maximum inundation elevation of 6.0m at GAL-1 is shown for comparison. The first observation is that houses with high elevations survived well, and those with low elevations were destroyed. With one exception of a house at elevation 6m destroyed near the shoreline, all houses with floor elevations over 5.5m survived. All houses with floor elevations less than 5.5m were destroyed. These general points were repeated at many other exposed Gulf Coast shoreline locations: all houses below some minimum floor elevation were destroyed, and houses survived well at higher elevations. The transition between completely destroyed and surviving houses occupied a very small range on these exposed locations, and was around 0.5m. This indicates the destructive power of these waves once they were able to reach flooring systems and remove structural supports.

Figure 7. Survival and destruction of houses around Crystal Beach near gauge GAL-1. (○) Surviving Houses; (□) Destroyed. The dashed line indicates the predicted maximum inundation elevation at GAL-1.

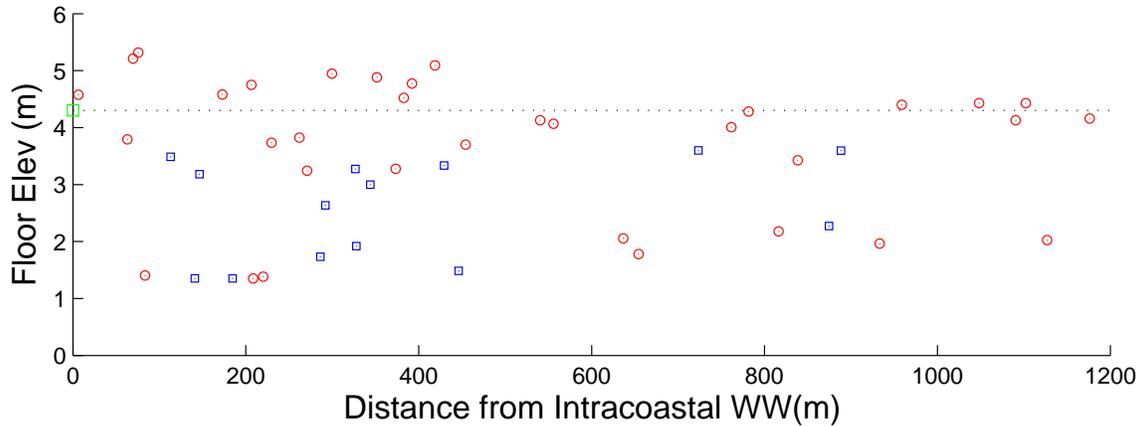
Figure 8. Survival and destruction of houses near gauge GAL-2 on the Gulf Intracoastal WW. (○) Surviving Houses; (□) Destroyed. The dashed line indicates the predicted maximum inundation elevation at GAL-2.

A very different picture is seen in Figure 8 for houses near gauge GAL-2. Here, surviving houses are found at all elevations from the at-grade house of Figure 6 to more highly elevated structures. However, of the houses that were destroyed, all were below the level of the maximum inundation elevation at gauge GAL-2. Above this line, all structures survived well. The reasons lie in the wave heights, which were very small at gauge GAL-2 as shown in Figure 4. These nonbreaking waves were too small to cause strong wave damage to even the houses that were inundated. Because of this, many well built houses survived even with significant inundation. It is impossible to determine the exact mechanism of destruction for houses that did not survive; however, some were likely to have been detached from their pilings by the upward buoyant forces, as was observed for several houses in other locations.

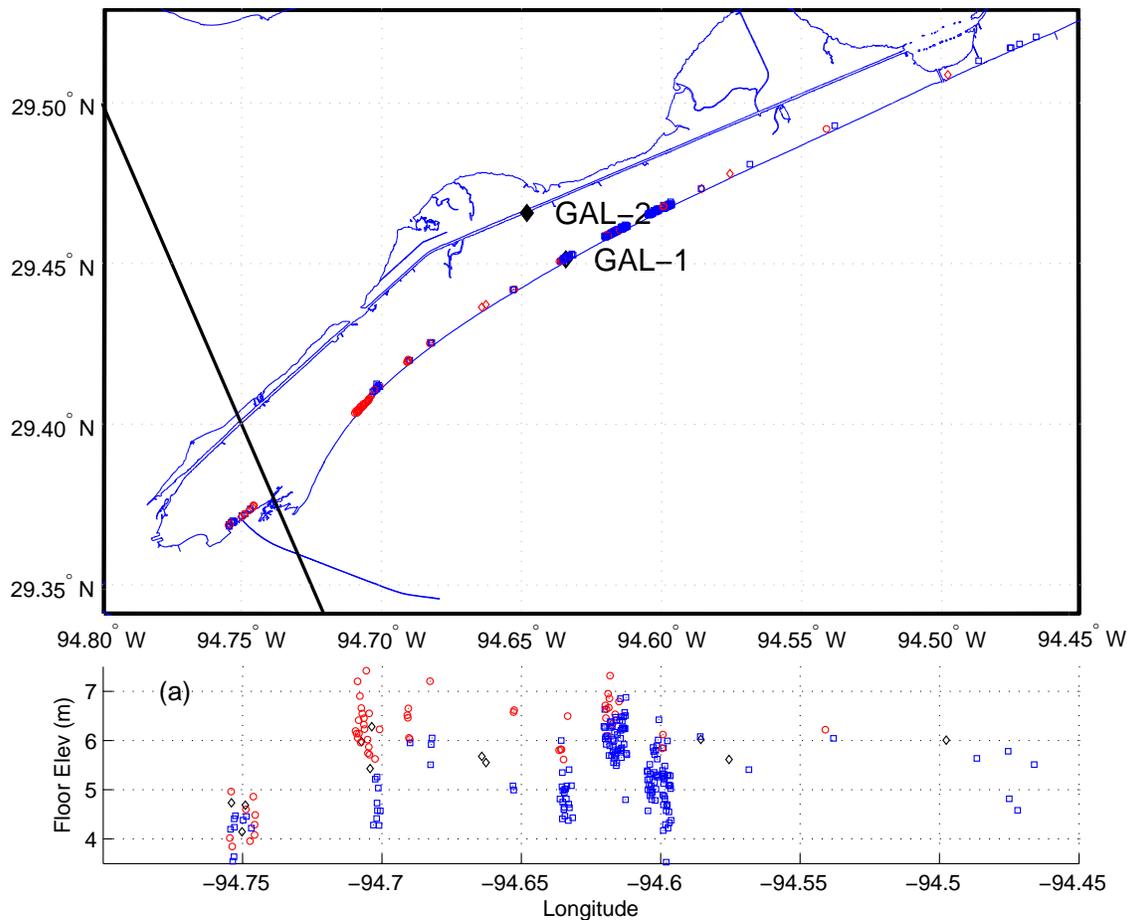
The importance of elevation may be seen in Figure 9, which plots the survival of houses in the first 150m from the Gulf of Mexico. Although there is some scatter, a clear division between survival and destruction may be seen along the peninsula. Once again, the more elevated houses survive, while lower elevations are destroyed. In most areas, the dividing line between survival and destruction is at around 5.5m NAVD88, although at around 94.62°W, there are numerous houses destroyed with floor elevations over 6m. The area at the SW tip of Bolivar around 94.75°W has two additional points of interest: (1) general survival elevations are much lower; and (2) the division between survival and destruction is not as clear as in some other locations.

Survival elevations appear lower here as surge had begun to decrease. Ike's eye passed very near to this area, and winds were not as consistently from offshore-to-onshore. This led to houses surviving at 4mNAVD88 and below, which is much lower than other open coast areas. The dividing line between survival and destruction also does not appear clear here. This appears to be because of very local sheltering effects: houses on the SW side of the jetty were exposed to relatively deep water waves approaching unimpeded through the Houston Ship Channel. Houses just 100m away on the NE side of the jetty were sheltered from ship channel waves by the jetty itself, and from Gulf of Mexico waves by a marsh which had grown up along the NE side of the jetty. Surge levels were likely similar on both sides of the jetty, but the different wave climate led to survival or destruction at very different building elevations.

Figure 9. Survival and destruction of houses 0-150m from the Gulf of Mexico. (Top) Surveyed houses; (bottom) elevations vs destruction. (○) Surviving Houses; (□) Completely Destroyed; (◇) Surviving with wave damage.
