Waves, Surge and Damage on the Bolivar Peninsula During Hurricane Ike

Andrew Kennedy, Matild Dosa, Francisco Zarama, and Jonathan Rager
Department of Civil Engineering and Geological Sciences
University of Notre Dame
Notre Dame, Indiana 46556 USA
Email: Andrew.kennedy@nd.edu
Phone: +1 574-631-6686

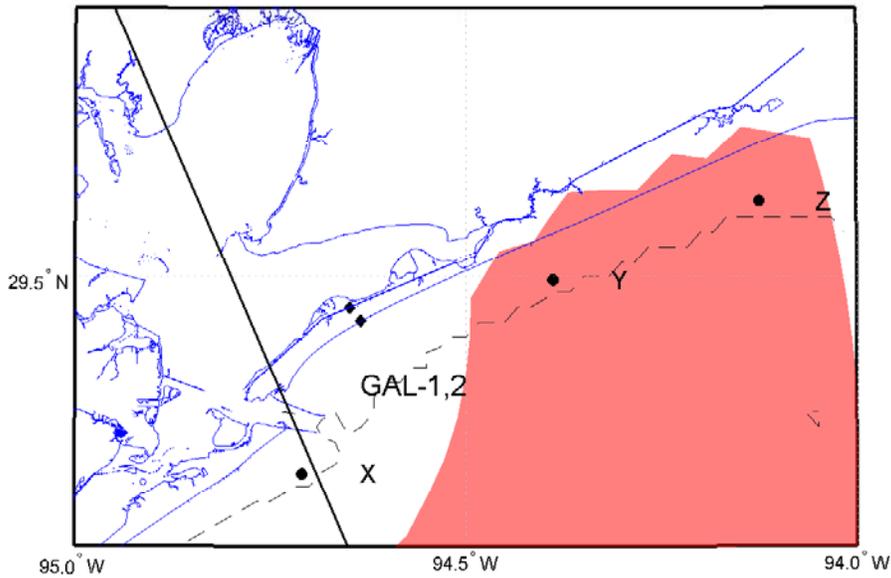
At 7:10 UST on September 13 (2:10 AM local), Hurricane Ike made landfall at the east end of Galveston Island, Texas. Figure 1 shows the path of Ike as it made landfall and the locations of five gauges installed prior to landfall by the US Geological Survey (GAL-1, GAL-2), and by the present authors' team (X,Y,Z). These five gauges were part of a much larger deployment extending from Louisiana to Southern Texas, but Ike's effects were disproportionately felt near the long, low-lying Bolivar Peninsula which has typical elevations around 2m. Despite being only a strong category 2 storm with maximum winds at landfall of 95 knots (49m/s, Berg, 2009), Ike's large, long-lasting surge and waves devastated large parts of Bolivar. These waves, surge, and the associated damage form the basis for this paper. In particular, we search for the dividing line between building survival and destruction, which seems to occur over a relatively small elevation range. The Bolivar Peninsula was just to the right of landfall, placing it on the strong side of the hurricane. H*Wind reconstructions (Powell et al., 1998) show winds blowing strongly from offshore-to-onshore for most of the storm, which acted to increase both surge and waves. Surge is extremely important for the particular case of the Bolivar Peninsula, as it allowed large waves to penetrate inland into areas they could not otherwise have reached.

Figure 1. Hurricane Ike's track, the extent of hurricane force winds, and wave/surge measurement locations (symbols). The shaded region shows areas that experienced Category 2 winds, while the rest of the figure experienced Category 1 winds.

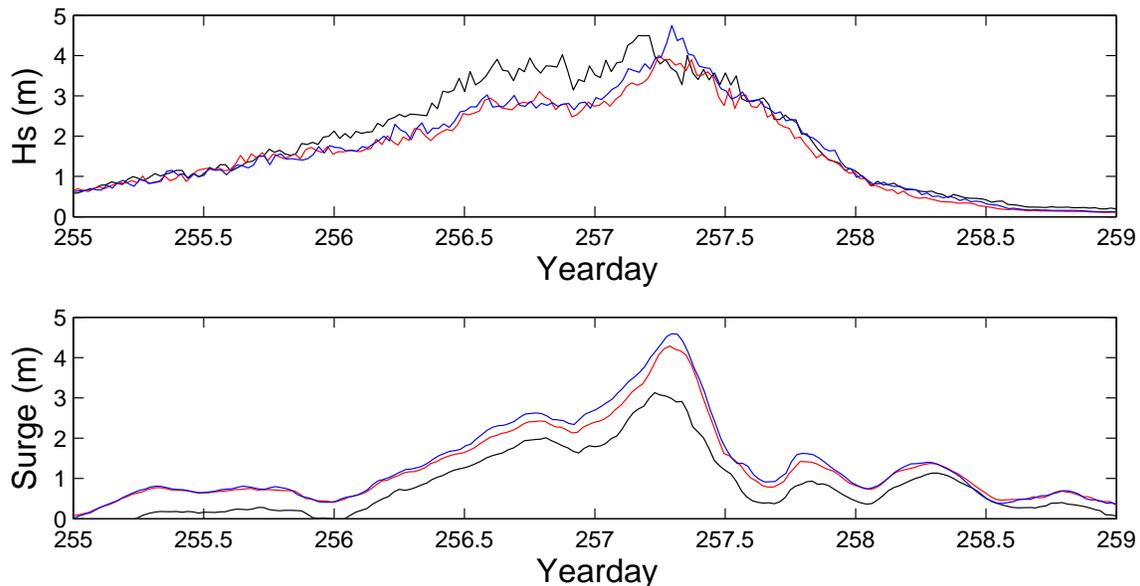
Figure 3 shows measured waves and surge at pressure gauges X, Y, and Z, which were 5-6km offshore in mean depths of around 9m. These spanned the length of the Bolivar Peninsula and give a good indication of coastal conditions. Surge at all gauges rose early, with 2m surge (NAVD88) occurring at gauges Y and Z around 18 hours before landfall. This early surge was essential to allowing waves to remove the protective dunes in parts of Bolivar before landfall, and increasing the time waves could impact shores and structures. Peak coastal surges reached 4.6m at Z, 4.3m at Y, and decreased somewhat with gauge X to the west near Galveston. (It should be noted that gauge X appears to have been on a bed that eroded approximately 0.5m, from the change in measured water levels before and after the storm.) Coastal significant wave heights were also quite large in this region, with maxima approaching 4-5m in areas with mean depths of near 10m. These heights were undoubtedly increased by surge increasing water levels by up to 40%. Wave spectra (not presented here) show relatively simple strongly-peaked spectra for gauges Y and Z on the strong side of the storm. Gauge X at landfall shows a more complex spectral evolution arising from the rapidly changing wind fields, with very broad and double-peaked spectra presumably the result of local and remotely generated waves. High resolution hindcasts of the combined wave-surge behavior are presently underway, and will be reported on in the near future.

Figure 3. Time Series of (a) Offshore Waves at gauges X, Y, Z; and (b) Surge. Landfall was at yearday 257.3. (black) Gauge X; (red) Gauge Y; (blue) Gauge Z.

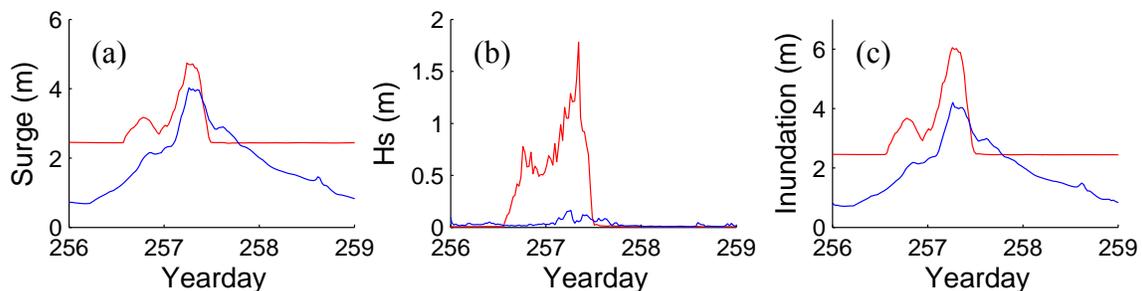
Figure 4 shows waves, surge, and estimated maximum inundation elevations for gauges GAL-1 and GAL-2. For GAL-1, which was immediately beside the Gulf of Mexico (see Figure 1), surge reached a maximum of 4.8m, while GAL-2 on the back side of Bolivar at the Intracoastal Waterway had a slightly lower maximum surge of 4.0m. A slightly larger surge on the exposed side of the Peninsula is as expected given the largely offshore-to-onshore winds. However, the wave heights are extremely different: GAL-1 has 1.8m maximum significant wave height, while GAL-2 has less than a 0.2m maximum. (It should be noted that the long wave assumption is probably overly conservative for GAL-2: using reasonable values of peak period may increase significant wave heights to 0.5m.) These huge differences in wave heights between the open coast location of GAL-1 and the more sheltered location of GAL-2 will be seen to lead to corresponding differences in damage. Inundation estimates top 6m at GAL-1, and are much less at 4.2m for GAL-2.

Figure 4. Time series of (a) surge; (b) wave height; and (c) Estimated maximum wave plus surge inundation. (Red) GAL-1; (blue) GAL-2.
